1890 Japy Clock

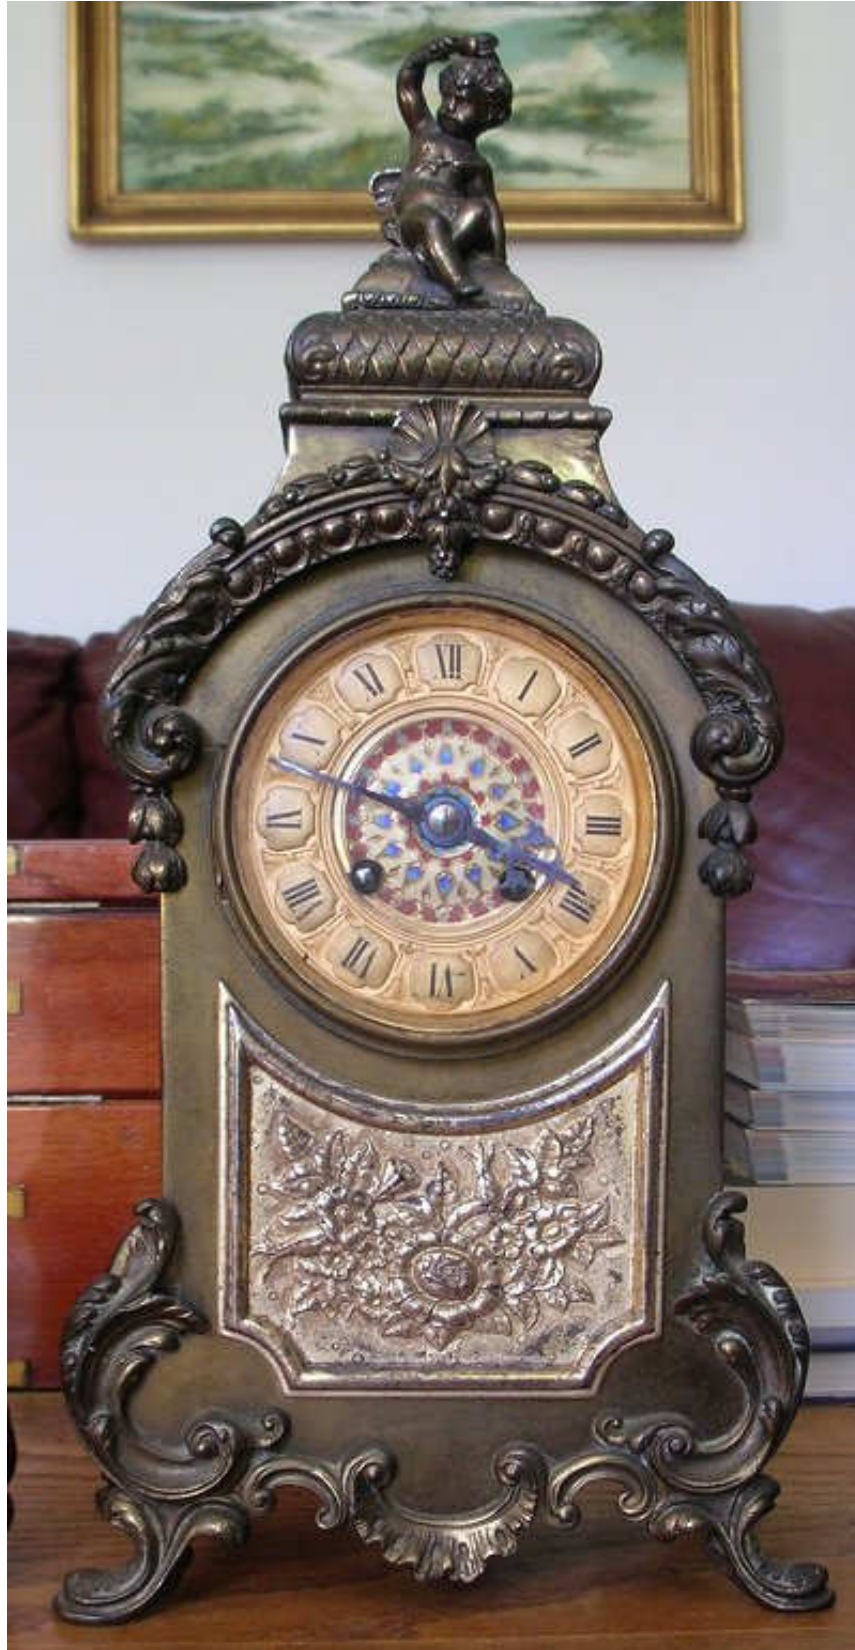
This Japy clock was in very poor condition mechanically because of a badly rusted escapement platform. The mechanism, except for a small amount of surface rust and tarnished brass, appeared to be in good condition otherwise. It showed very little wear but a lot of repair work, not a good sign. The platform was in bad shape, with a lot of rust on the regulator, the balance wheel and the hairspring. What I went through to repair this clock became one of my most interesting repairs in years, and I decided to write an essay about it for the benefit of other horologists.

This is when the investigation became interesting: the amplitude of oscillation of the balance wheels on both platforms was more or less *equal*. Since the Russian platform was a good performer, this suggested that there was nothing mechanically wrong with the English Lever platform on my Japy clock. The problem was therefore in a weak mainspring, if there were no rough pivots or other problems in the gear train. Upon taking the mechanism apart, it became clear that the mainsprings in the time and strike trains were the same, and they both appeared to be original. They were 0.009" thick. I replaced the time mainspring with a new one that was 0.0011" thick and, based on my estimate, almost twice as powerful as the original.

This clock had virtually no visible wear. At this point it became clear that the reason why there were so many replacement bushings. The clock had never worked properly with the English Lever platform because the mainspring it had was for a French or Swiss Cylinder escapement, which required much less power. When the mechanism was exported to the UK, the time mainspring needed to be upgraded for use with an English Lever escapement.

The clock ran well with the new mainspring, which, when fully wound, provided enough power to give the balance wheel a full 360° turn (that is, half a turn each way from centre). Upon a test run, however, the clock lost a lot of time. I expect that the hairspring was weakened by the formation of rust on its surface.

Using a Timetrax timing machine, I got a reading of 17732 without the regulator. What I wanted was 18000 beats per hour. I removed one screw from the balance wheel and took a reading. Removing only one screw caused the balance wheel to become out of poise (that is, it had an uneven weight distribution). The poise problem would not be a serious issue in this case because the balance wheel would rotate only on a horizontal plane, and would therefore not be affected by gravity in its movement. (It would be a serious problem in watches, wherein the balance wheels rotate in all positions.) The reading I got with one screw removed was still slow, so I removed another screw from the other side of the balance wheel, this time expecting the clock to run too fast. With two screws removed, I got a reading of 18005. Surprisingly, it would not be necessary to undercut any of the screws to remove more weight, nor would I need to add timing washers, since this was probably close enough: a reading of 18013 means one minute fast per day.

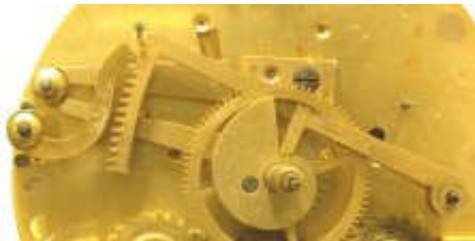
The mechanism appeared poorly, so I decided to use photos from other clocks in this explanation. This Japy clock had the same rack and snail strike mechanism as my other Japy, from which I present this photo.

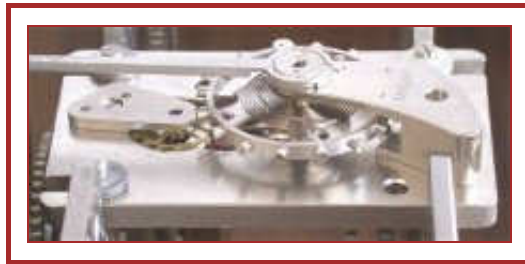
To determine the extent to which the platform was damaged, I removed the balance wheel and removed some rust between the pallet bridge and the balance wheel to create some clearance. Despite the rust on the hairspring, the clock ran, albeit poorly. Since English Levers often perform poorly, it was time for an experiment. I removed the platform and placed another platform in its place. I am familiar with the Russian platform with the Swiss Lever escapement, having used one on a French carriage clock. Here is a photo of a Russian platform.
