## Gear Photos

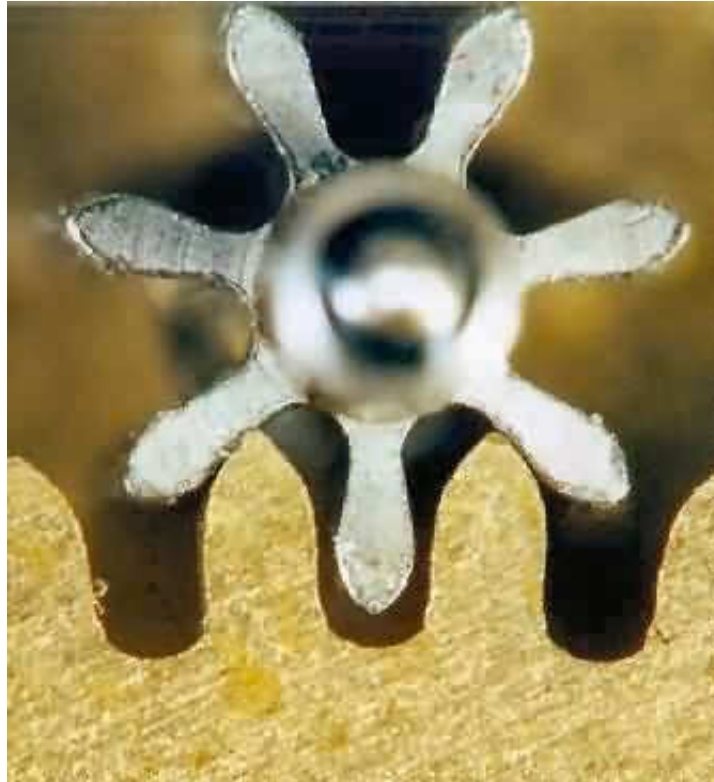
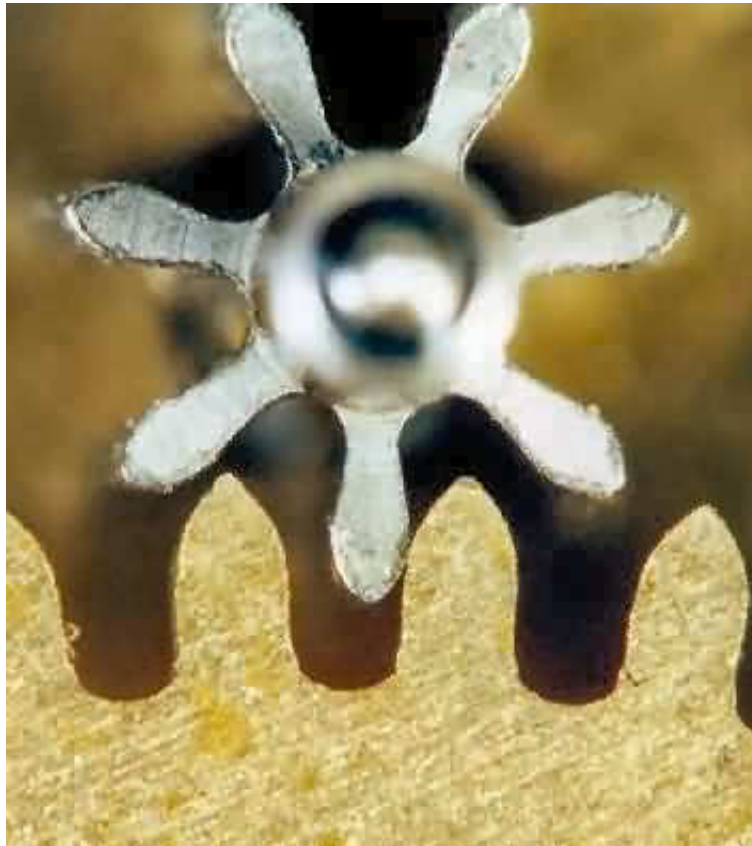
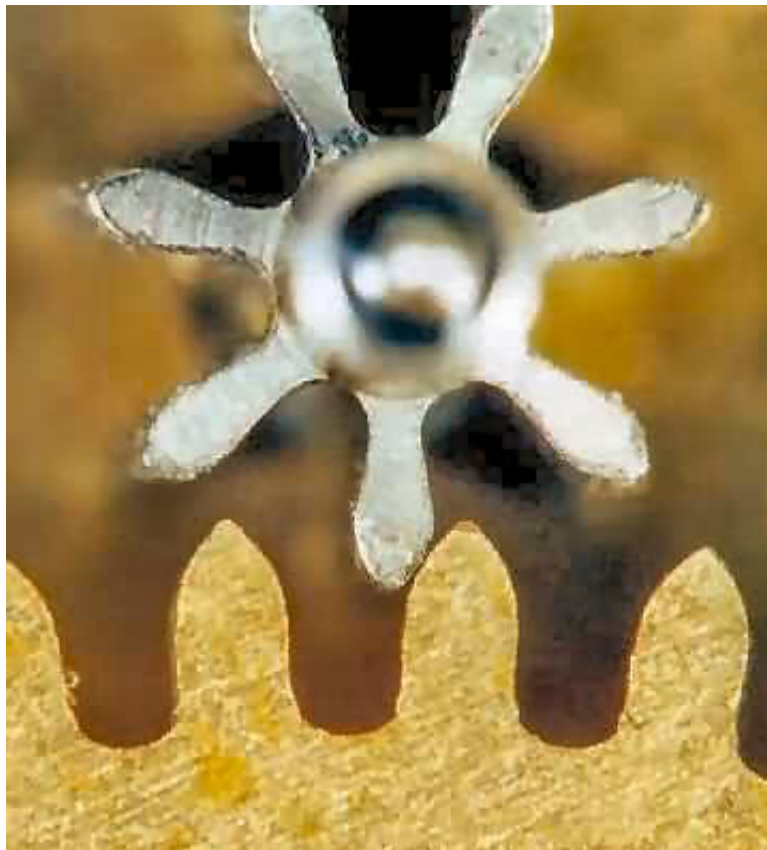
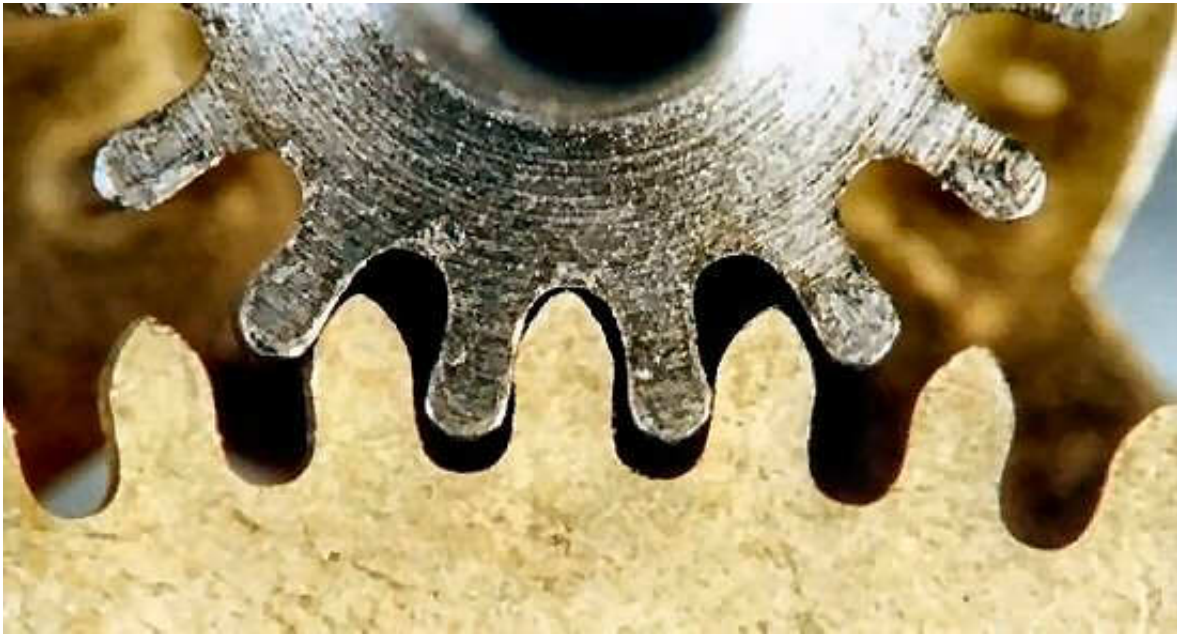
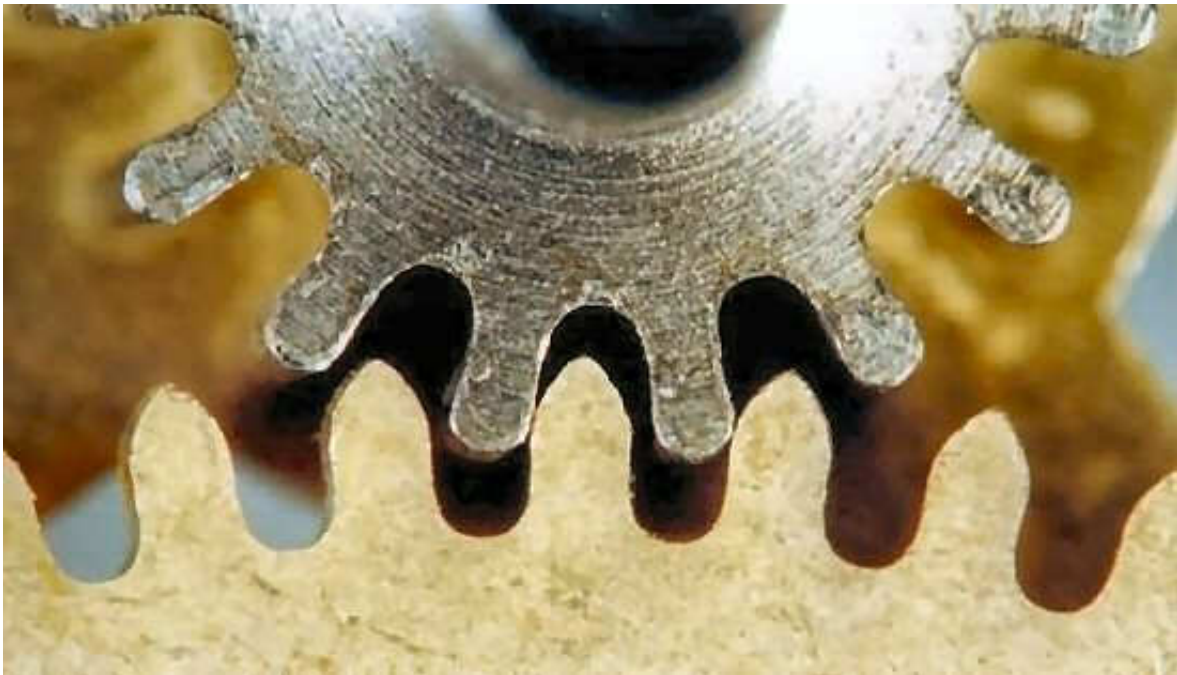
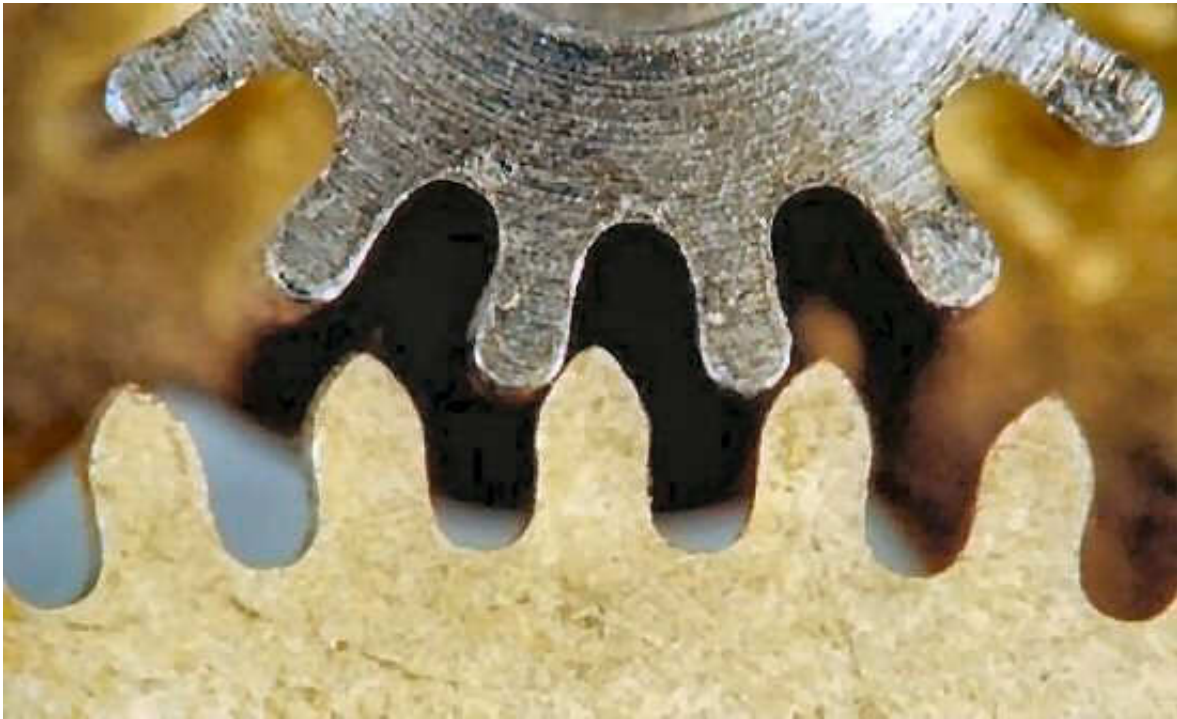
Below are photos of two pairs of Urgos gears (circa 1985: modern, mass-produced parts). You can see how the teeth interact when the depthing is too deep, (approximately) correct, or too shallow. Notice also the difference in the size and tooth count of the larger pinion. The last two photos are from an Omega 551 (circa 1960) and a Rolex 1570 (circa 1969) wristwatches.
